A CRITICAL ANALYSIS OF THE STATE OF THE ART  
IN CONTAINERIZATION

Control Systems Research, Incorporated  
Arlington, Virginia

November 1970

4. DESCRIPTIVE NOTES (Type of report and inclusive dates)  
Final Report

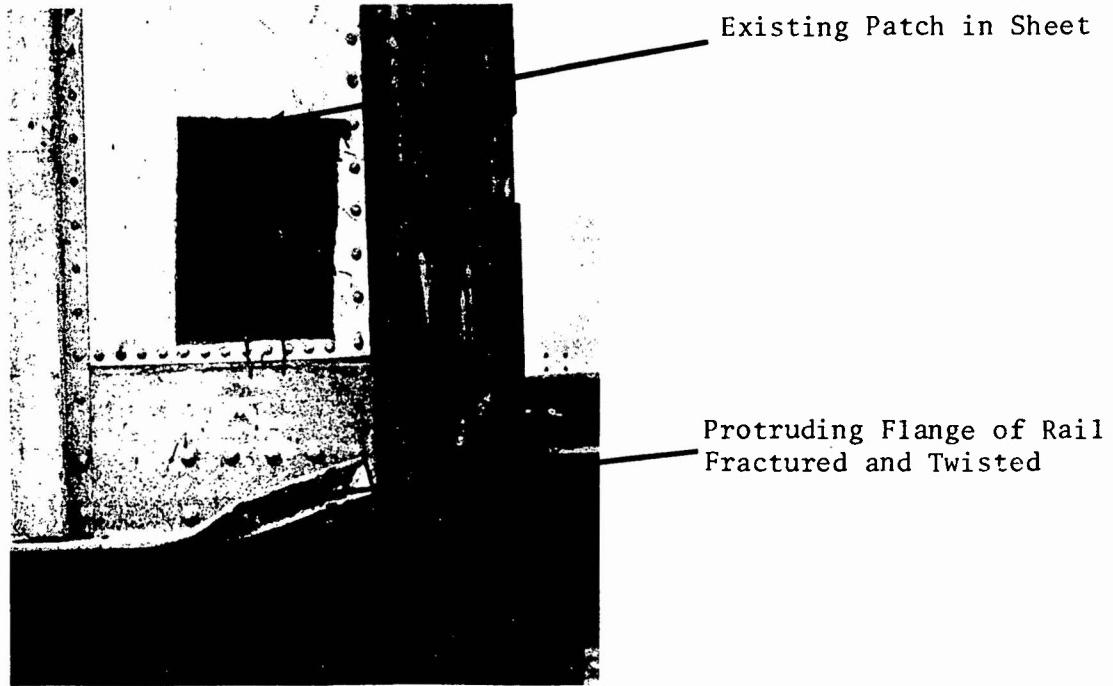
Figure 5-2. Typical Bottom Rail Damage

The flange on the bottom rail often protrudes outward and is especially vulnerable. It can be dented, torn, and/or twisted. See Figures 5-2 and 5-3 for typical flange damage. The work of a hard and perhaps sharp body acting on the container is plainly visible.

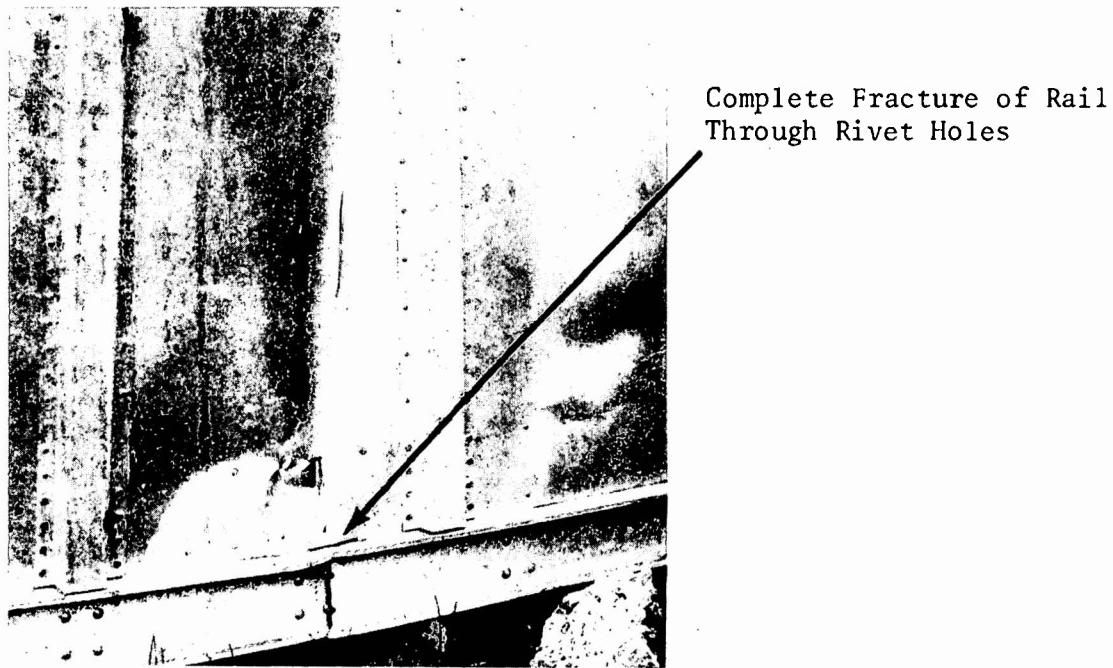
Figure 5-4. Typical Bottom Rail Damage

A complete fracture of a lower rail as in Figure 5-4 is a catastrophic failure since there is no alternate load path. Note that the fracture passes through the rivet holds where it undoubtedly

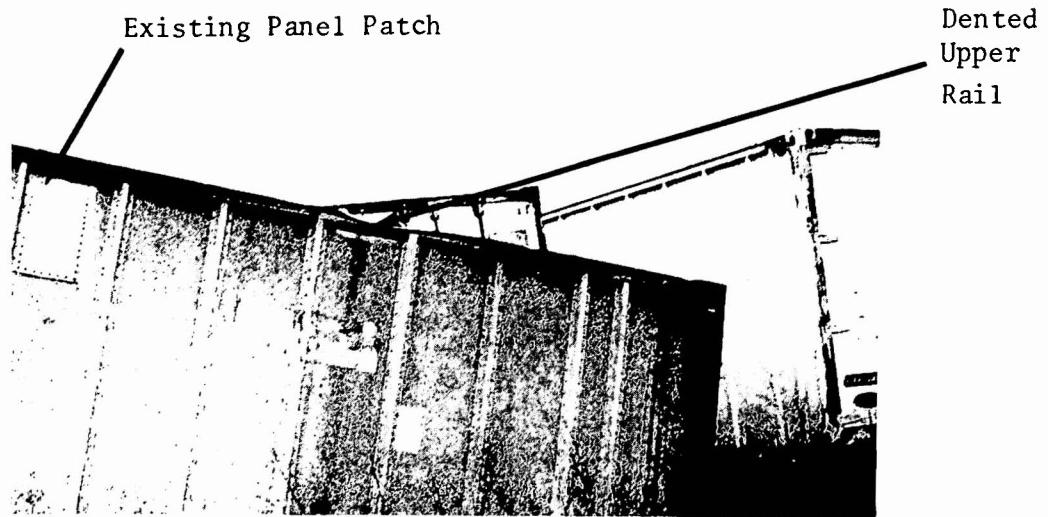
Figure 5-7. Typical Top Rail Damage

Top rails are subject to similar kinds of damage as that experienced by bottom rails. The causes of the damage are somewhat different but the deformations are equally large. Whereas bottom damage can occur when a container contacts an uneven surface or is struck by a mobile material handling unit or another container, there are counterparts working against the top. Handling units engaging a container can be misaligned and dent the top rails. Figure 5-7 shows a dented top rail. Further consequences of a catastrophic nature can follow from simple damage to the top rail. When a container is lifted from the top, this member acts as the top chord of a truss and is in direct compression. The failure mode of the top rail during lifting would be by buckling. The dent accelerates the

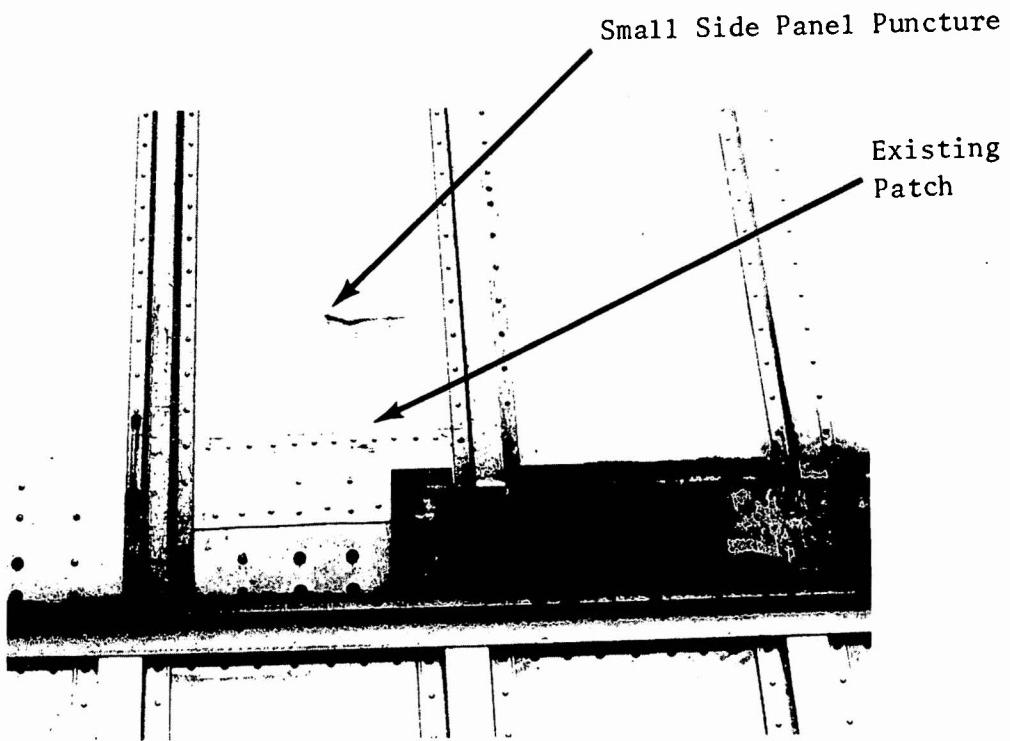
Figure 5-8. Typical Minor Panel Damage

Some typical panel damage is shown in Figures 5-8, 5-9, 5-10 and 5-11. Note in Figure 5-8 a small patchable puncture just above a location where a patch had already been applied. Both these damage items are close to the forklift pockets suggesting that they were caused by the tines of a lift truck. Figure 5-9 is a steel container which was punctured from the inside.

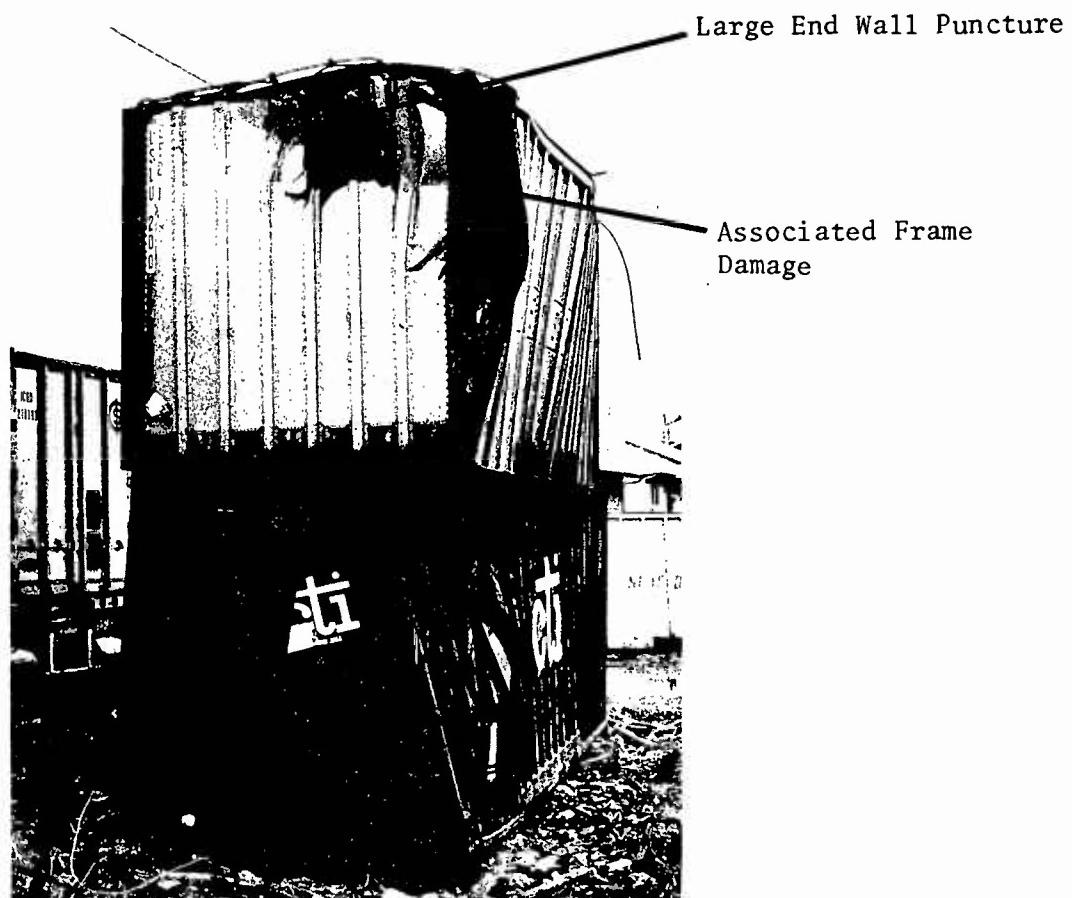
Figure 5-10. Typical Major Panel Damage

An example of major panel damage is seen in Figure 5-10 where severe end frame distortion is also present.

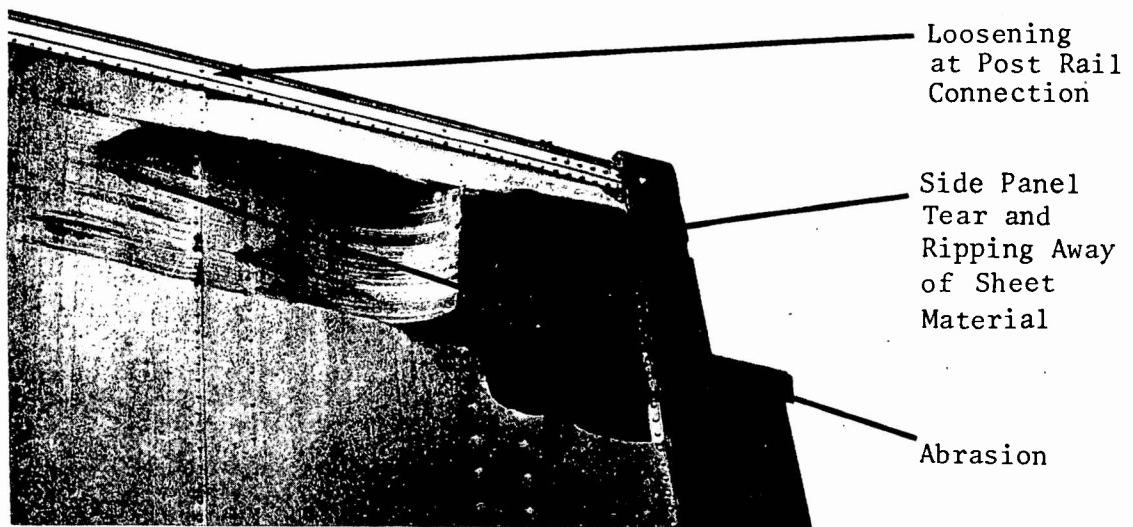
Figure 5-12. Typical Major Panel Damage

Further panel damage is included in Figures 5-12 and 5-13 where a substantial tearing action led to the results of Figure 5-12. Note here that this is an interior post aluminum design and that one of the two posts involved is probably reusable whereas both would have been in need of replacement had they been exterior. Note also that the end post, when it was forced inward,

pulled a dozen or so rivets through the sheet material. Figure 5-13 shows the action of squeezing forces on the verticals of the front end frame with crumpling of the sheet while the panel stiffeners appear free from distortion.

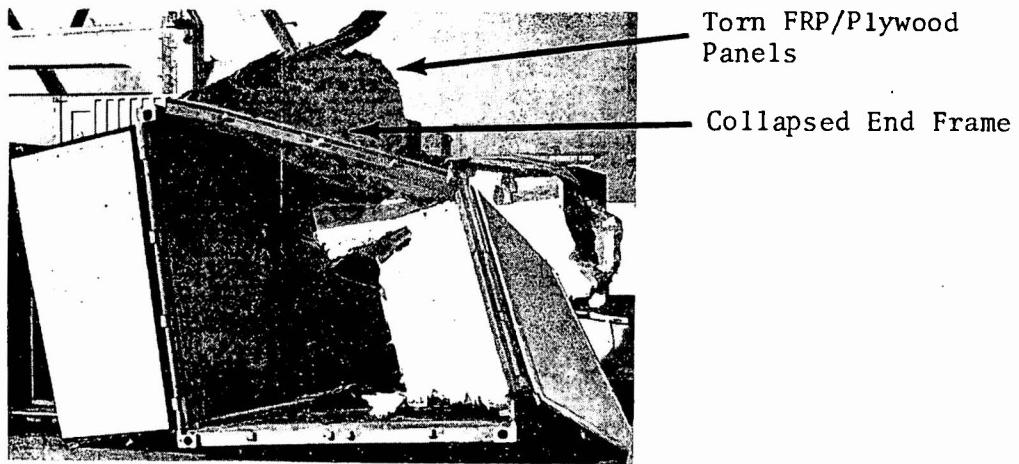
Figure 5-15. Typical Major End Frame Damage

Damage to the end frame consists of many of the same types listed under rail damage (dents, etc.). However, these are less frequent in occurrence by comparison. The type of major end frame damage experienced occurs from racking forces which deform the frame in a lateral direction, as shown in Figure 5-15.

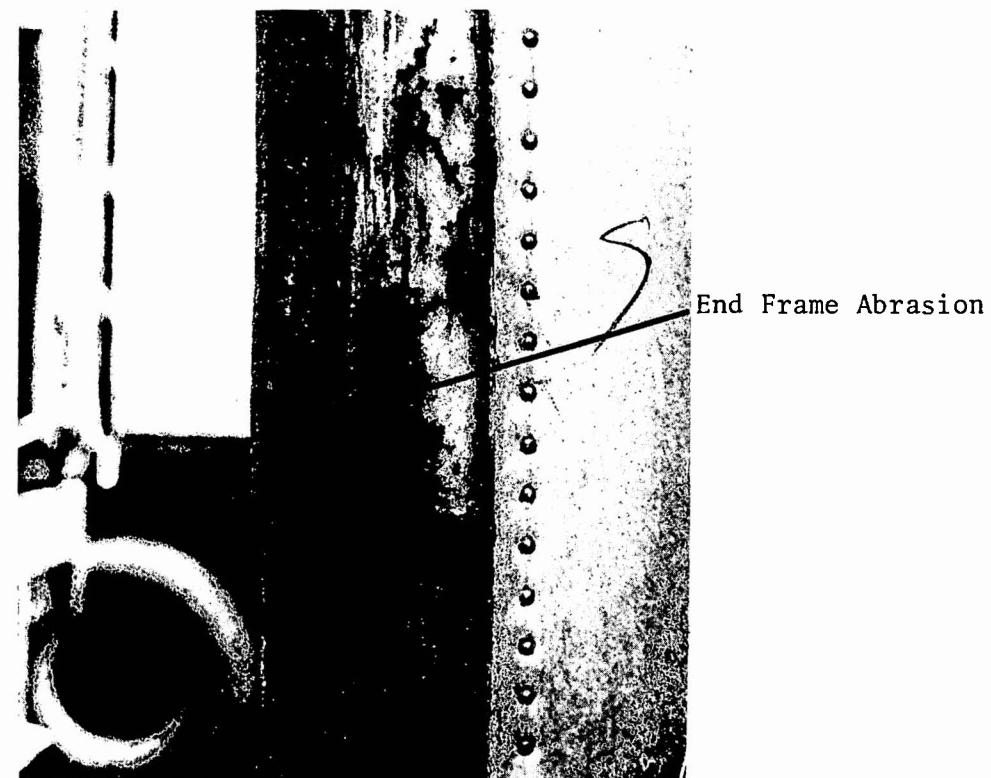
Figure 5-16. Typical Minor End Frame Damage

The vertical members of the end frame almost always suffer from abrasion damage as shown in Figure 5-16; however, this does not immediately affect the overall strength of the member frame. This condition does, however, accelerate the rusting of end frames which

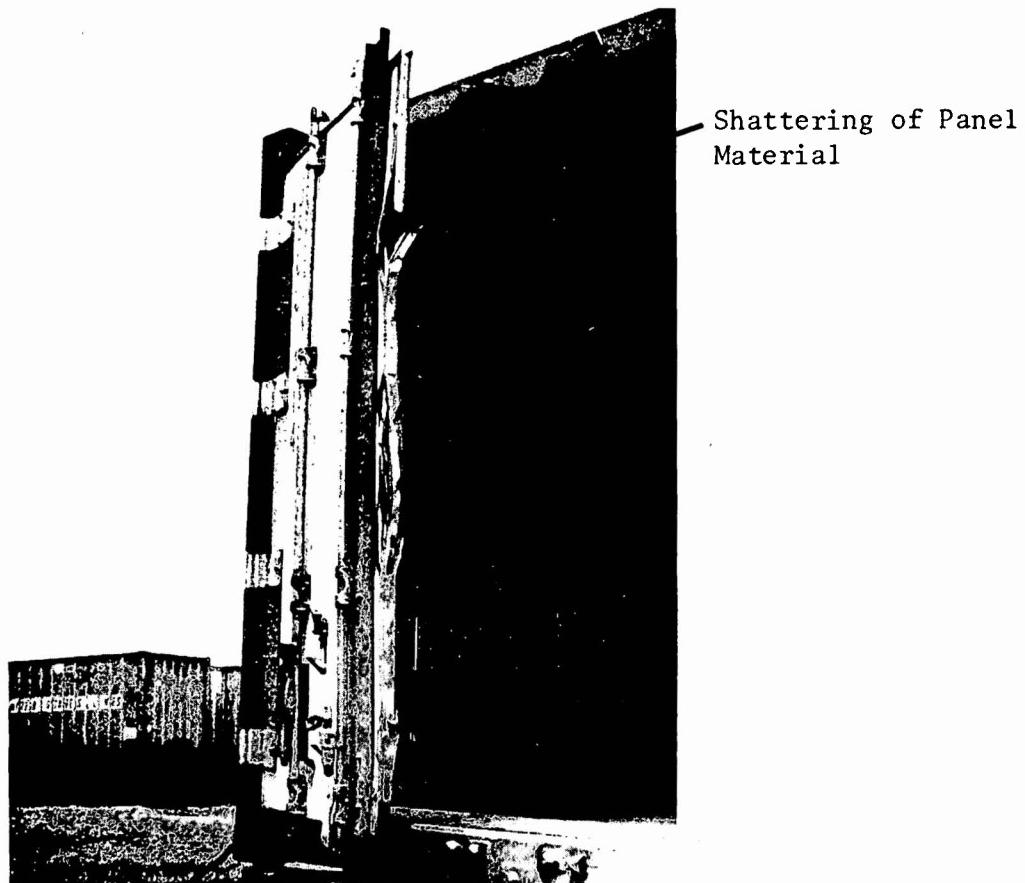
Figure 5-17. Typical Door Damage

impairment, door sill dents, and misalignment of locking bars and hardware. A torn door edge is given as an example of minor damage in Figure 5-17.
